**PHOTOGRAMMETRIC ANALYSIS OF
GRAND CANYON BEACHES**

For: Bureau of Reclamation
Arizona Projects Office
Phoenix, Arizona

By: Gary Robertson & Assoc., Inc.
2901 N 78 St. Suite 200
Scottsdale, AZ. 85259

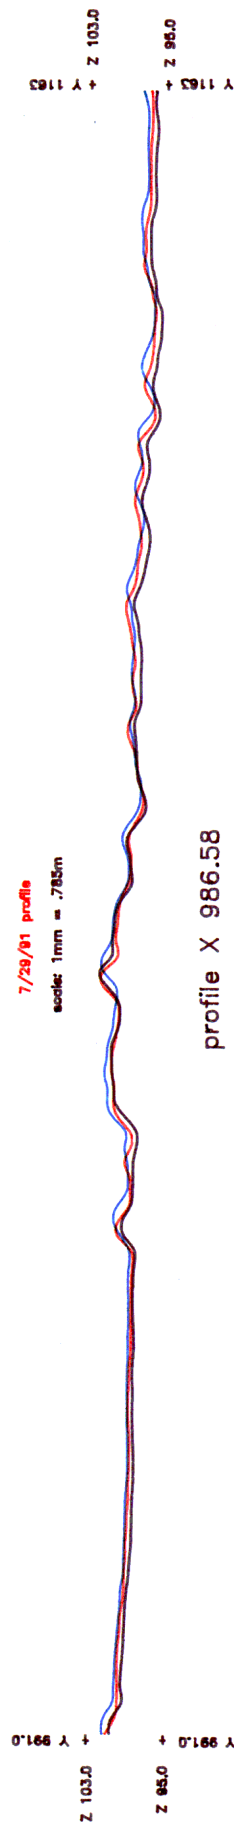
7/29/91 profile

scale: 1mm = .785m

GRA initiated an additional repeatability test utilizing APO staff and the APPS IV analytical plotter. The test differences is from data collected for the 6/29/91 epoch. This data represents delta Z comparisons from a profiles duplicated on the same photographic stereo pair.

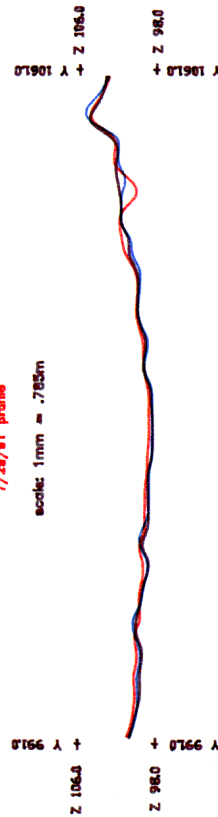
profile X 986.58

7/29/91 profile

scale: 1mm = .785m

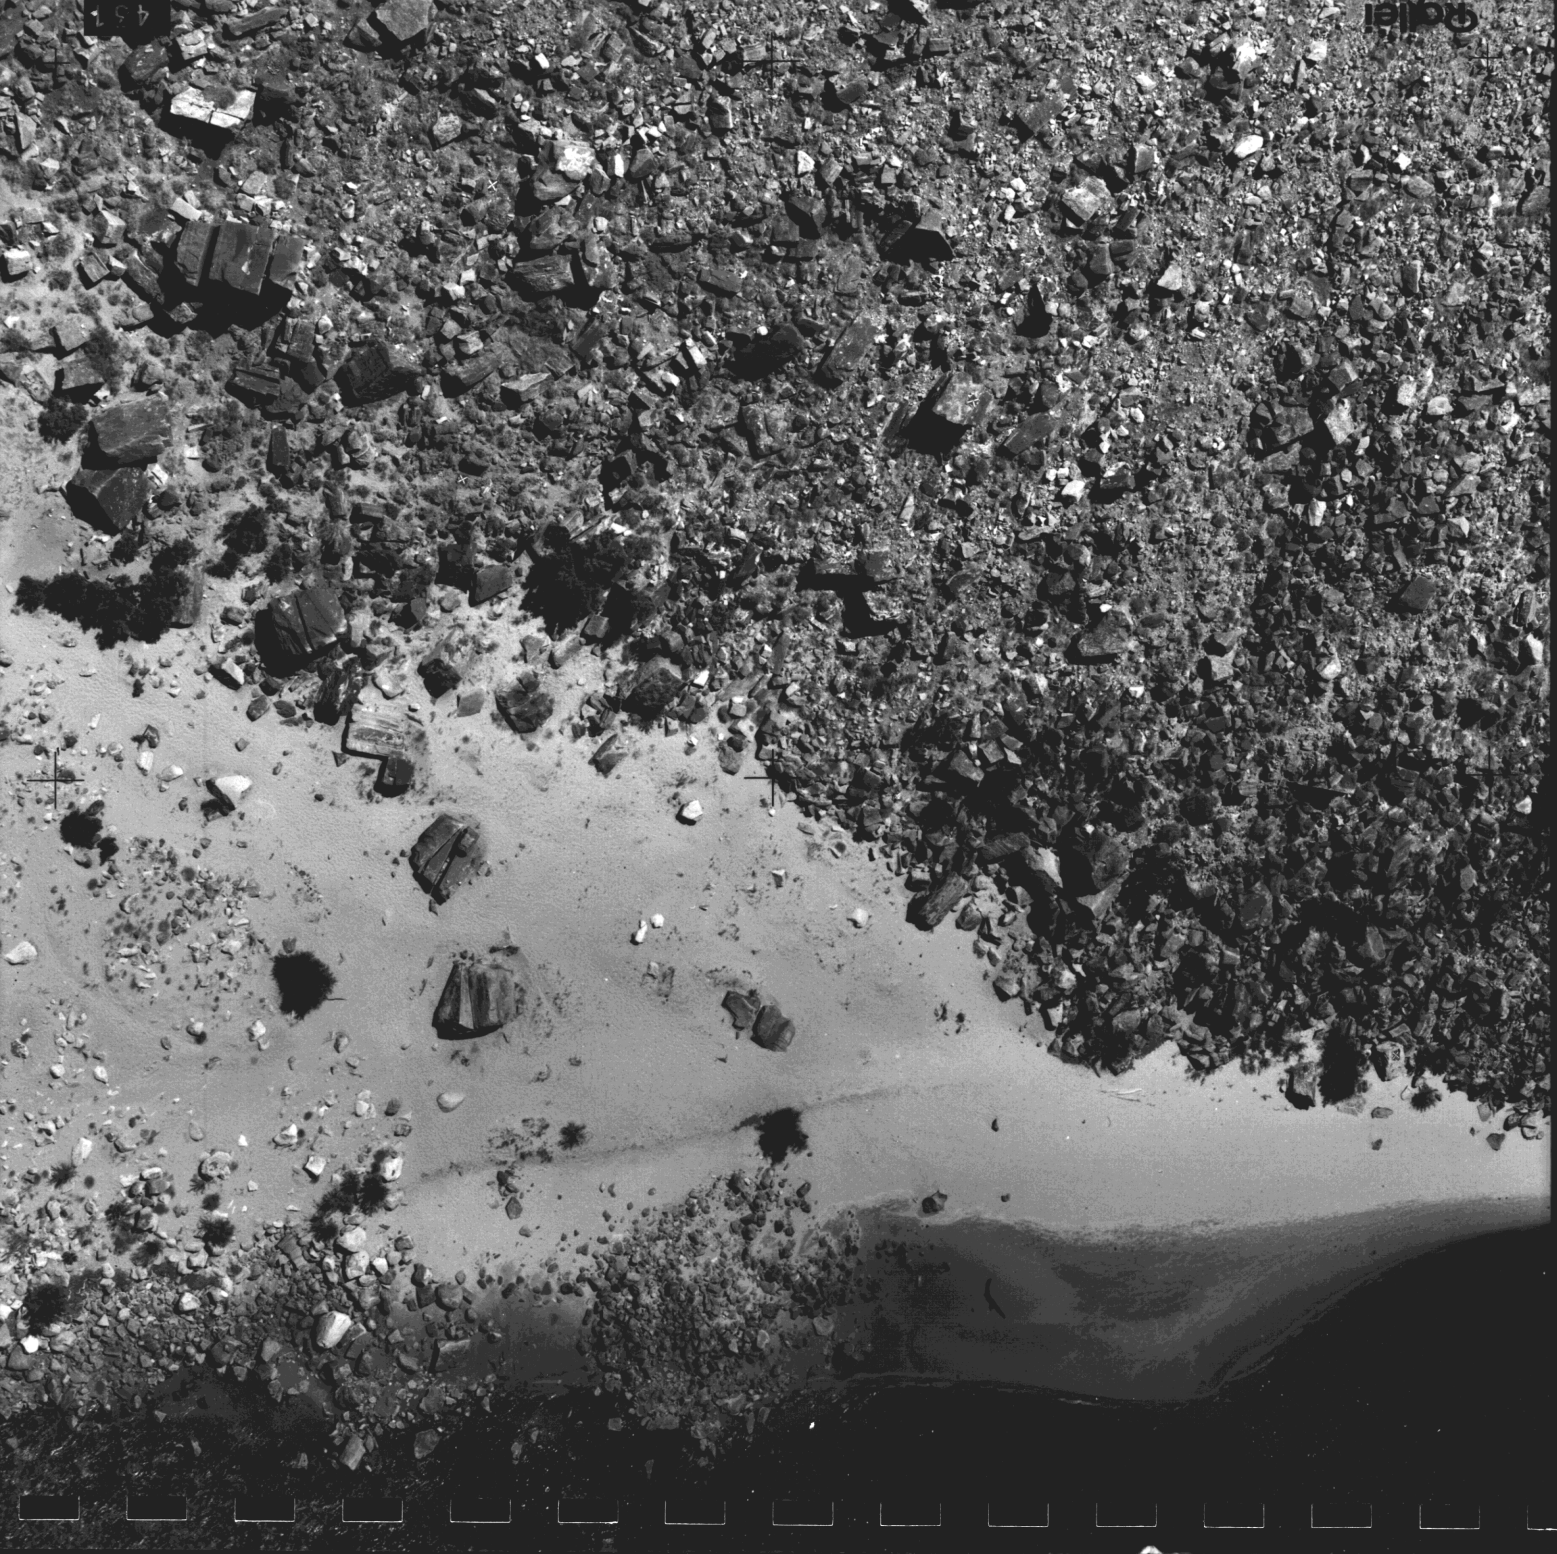
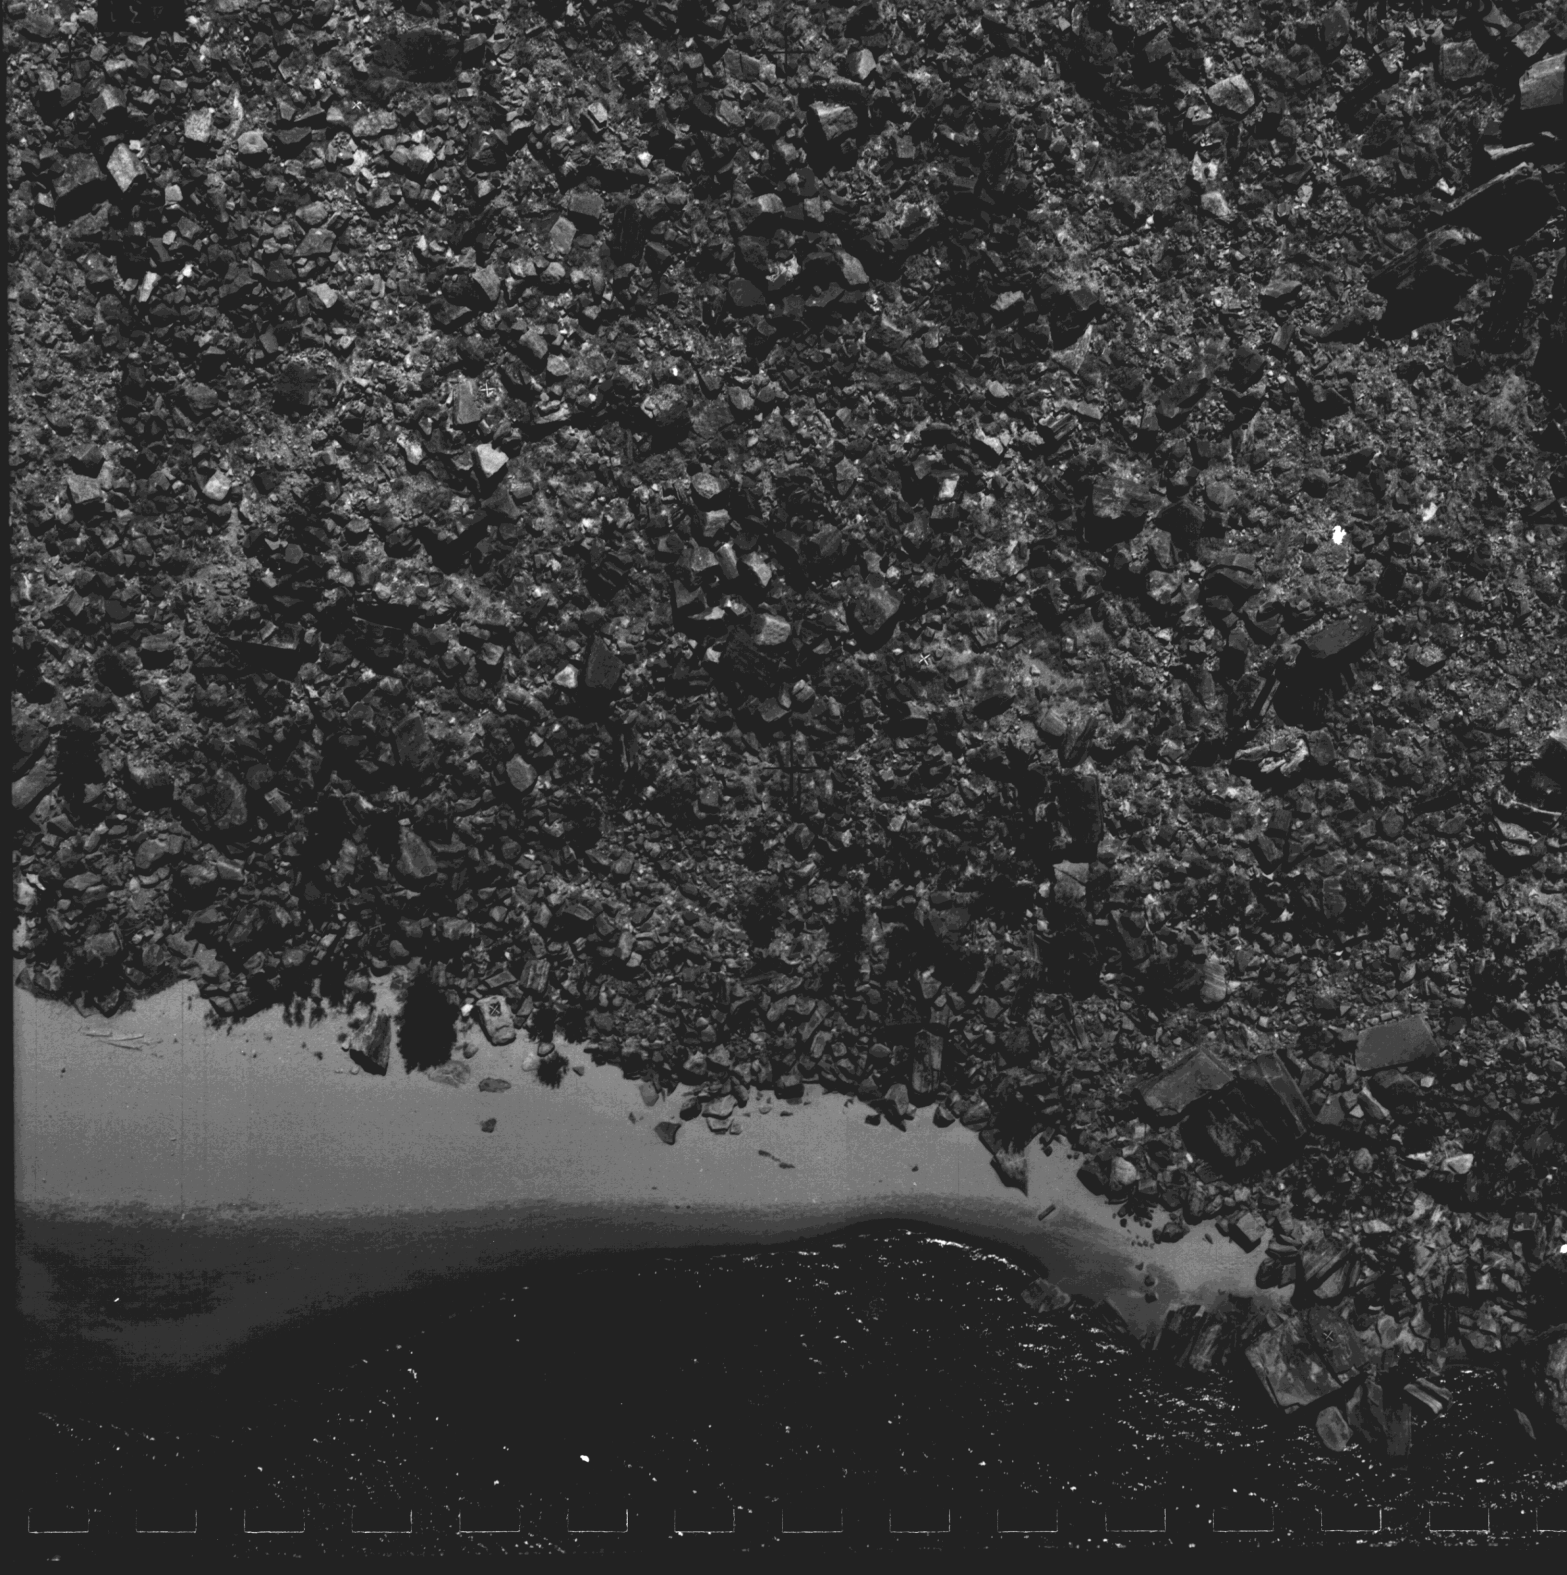
APPENDIX A

The following are prints of the 8.0 mile test beach to illustrate the scale and overall coverage.
